APPLICATION OF ULTRASONIC TECHNIQUES FOR QUALITY ASSURANCE OF SALT CONCRETE ENGINEERED BARRIERS: SHAPE, CRACKS AND DELAMINATION

Ernst Niederleithinger, Frank Mielentz, Ute Effner, Matthias Behrens, **Tyler Oesch**

Bundesanstalt für Materialforschung und -prüfung (BAM), Berlin

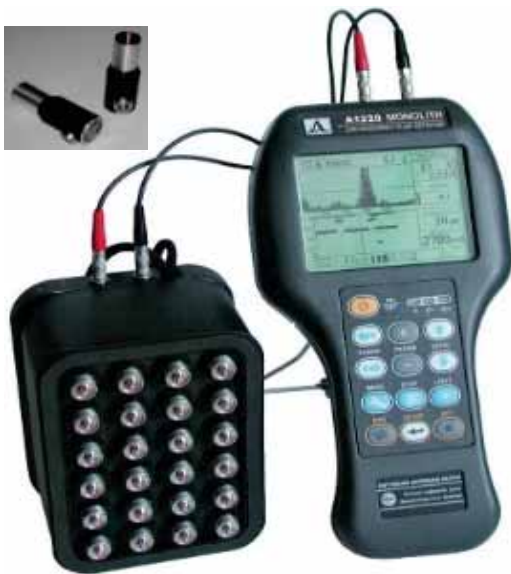
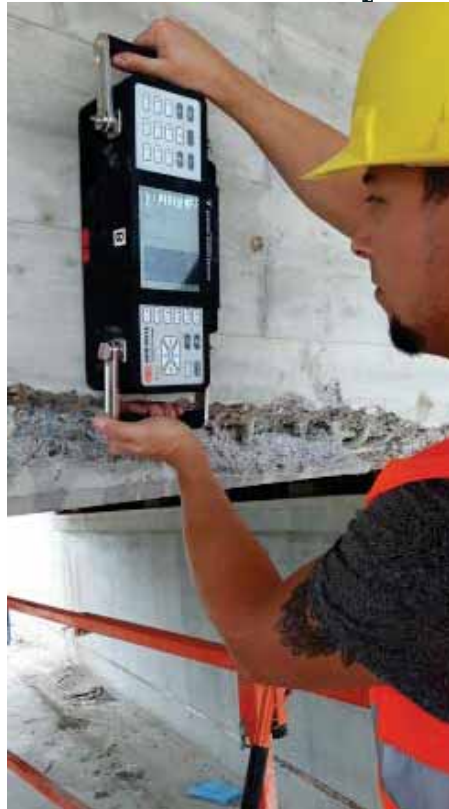
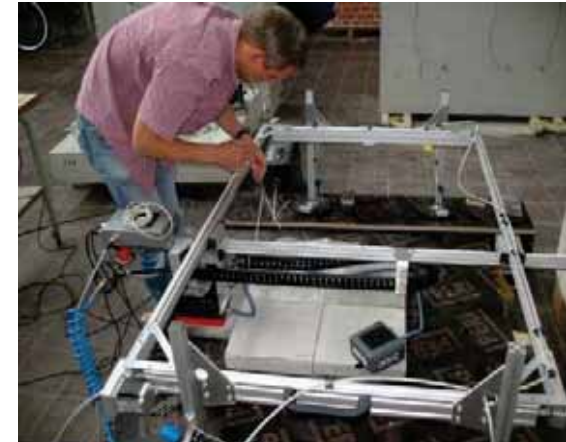
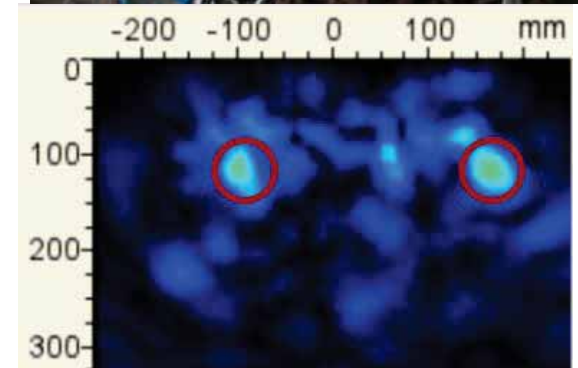
Ultrasonic-Echo Commercial instruments for concrete inspections

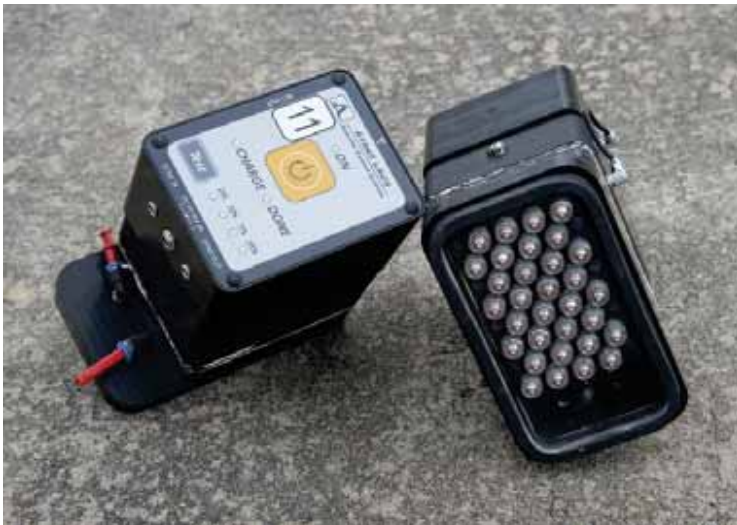
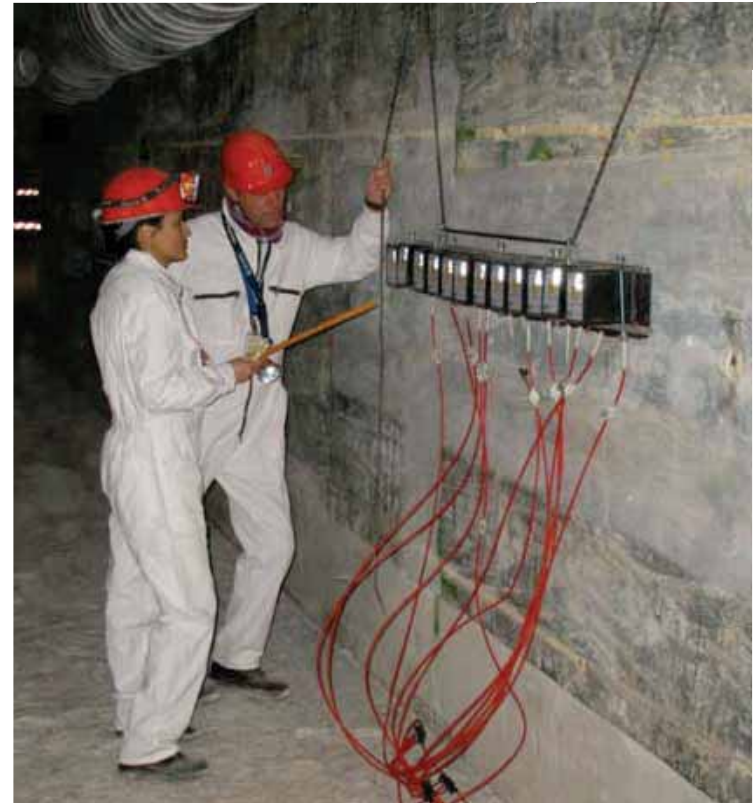
LAUS Large Aperture Ultrasonic System

LAUS US-Module:

- 32 coupled shear wave probes each
- Frequency: 25 – 75 kHz

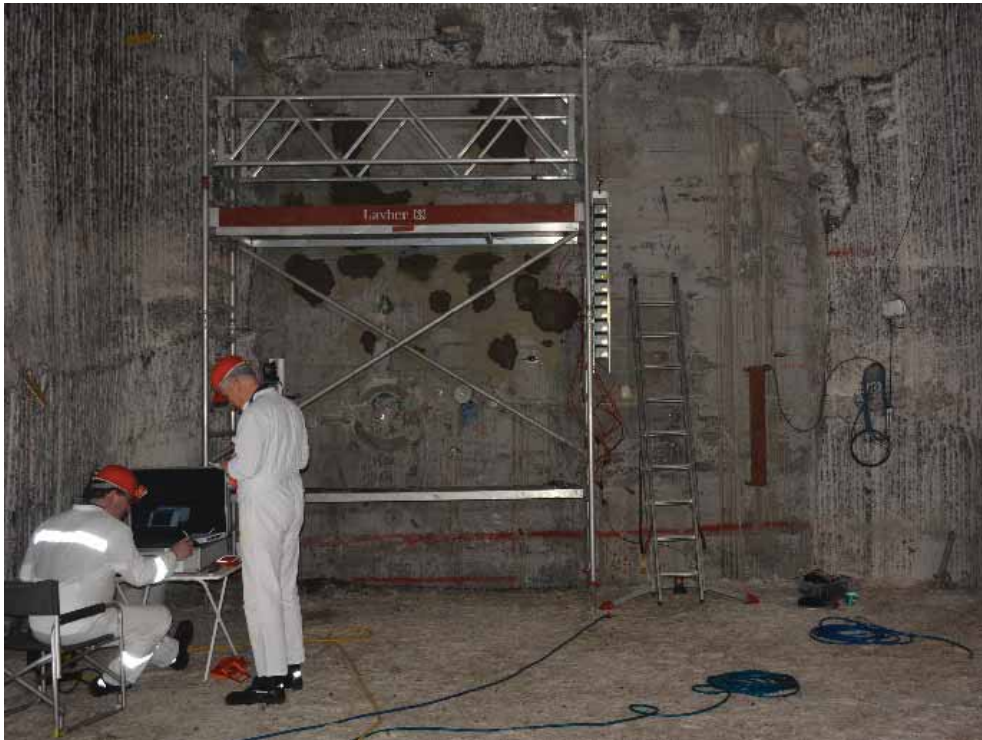
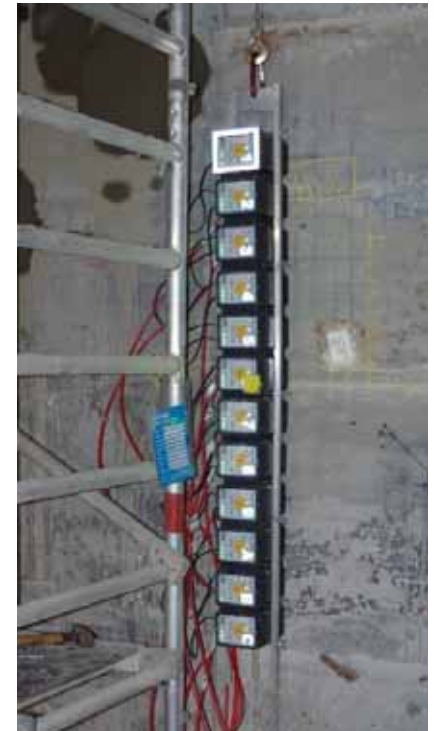
LAUS measurements on front face of the trial engineered barrier

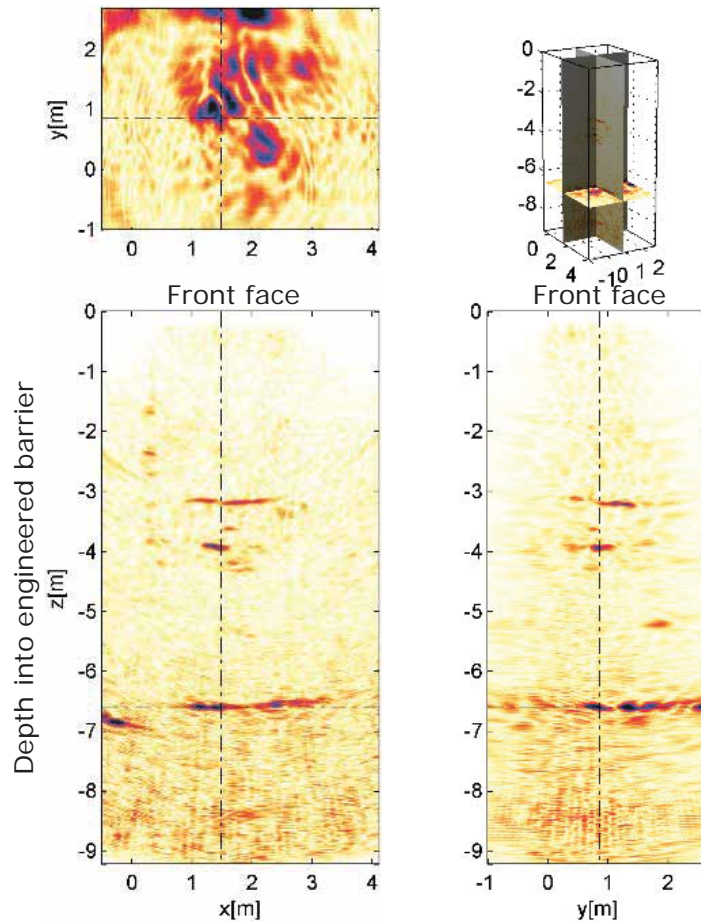
Ultrasonic-Echo - LAUS

First results

- Depth of penetration > 6m
- SAFT-Reconstruction
- Reflections from cracks and objects
- "Blind" near surface
- Metal sheet at 8,5 m ?
- Boundary salt concrete /rock salt?

- Methods from NDT-CE transferable
- Crack +/- parallel to surface visible
- Objects detected
- Depth of penetration with LAUS > 8 m
- RTM gives new insight, but still limitations in image quality

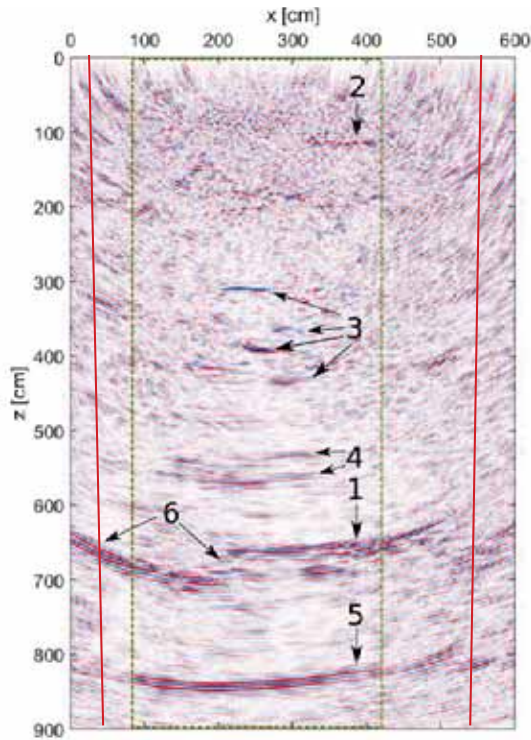
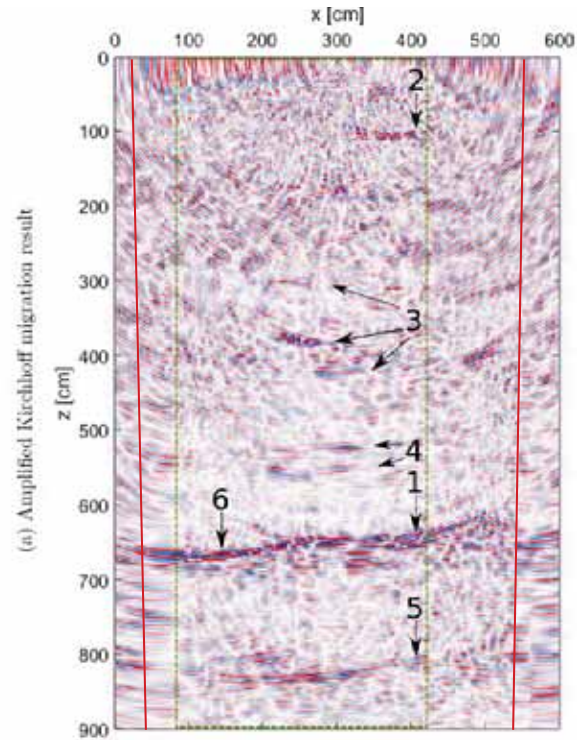
Ultrasound-Echo Imaging with Reverse Time Migration (RTM)

Kirchhoff
(SAFT)

RTM

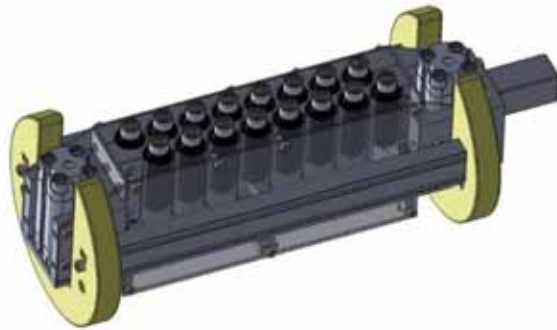
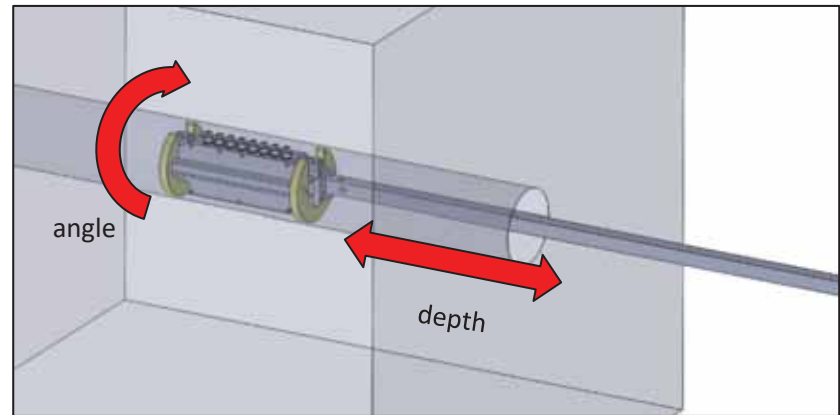
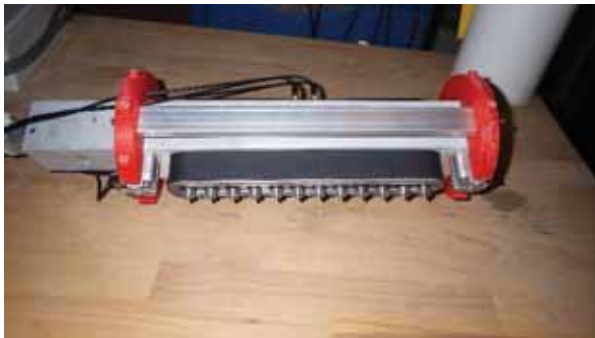
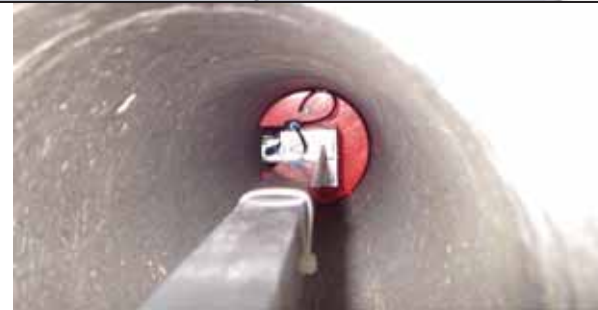
Ultrasonic-Echo Borehole probe

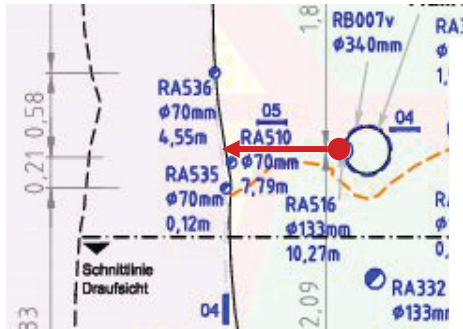
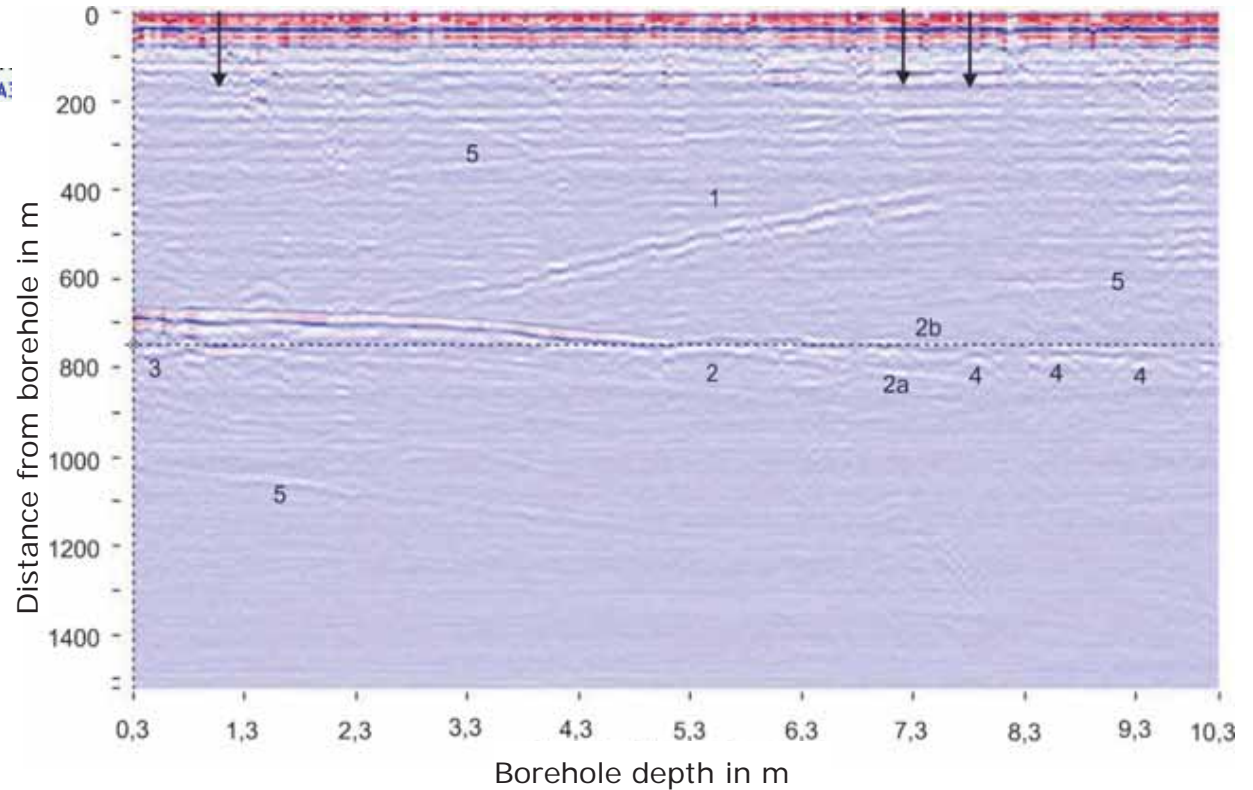
Ultrasonic-Echo Borehole probe – first results from the trial site

- It works!
- Cracks and boundaries perpendicular to surface visible
- Limitations in image quality and depth of penetration

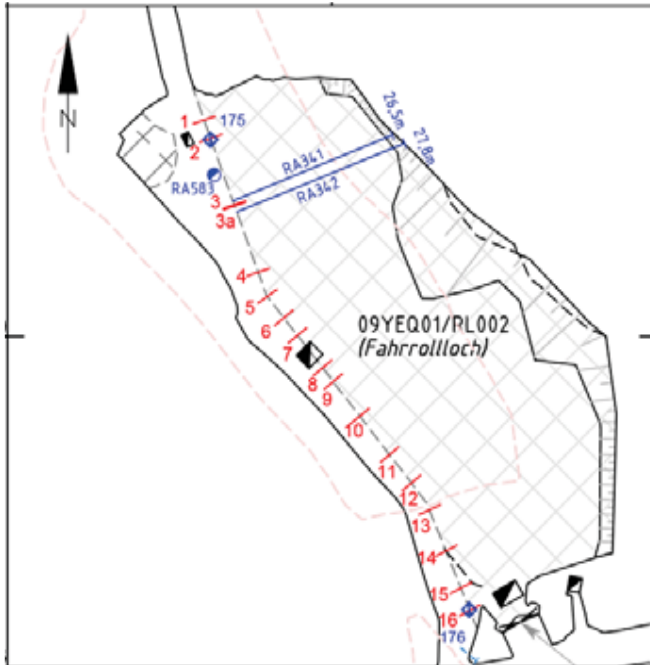
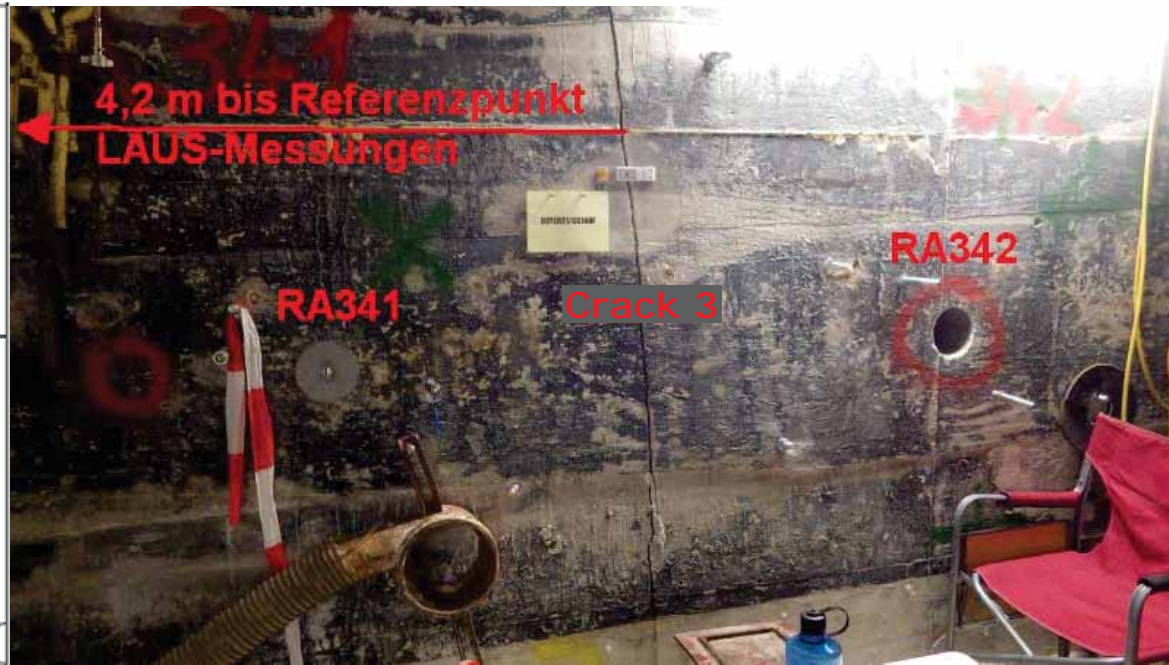
Ultrasonic-Echo Borehole probe – results from a massive salt concrete body

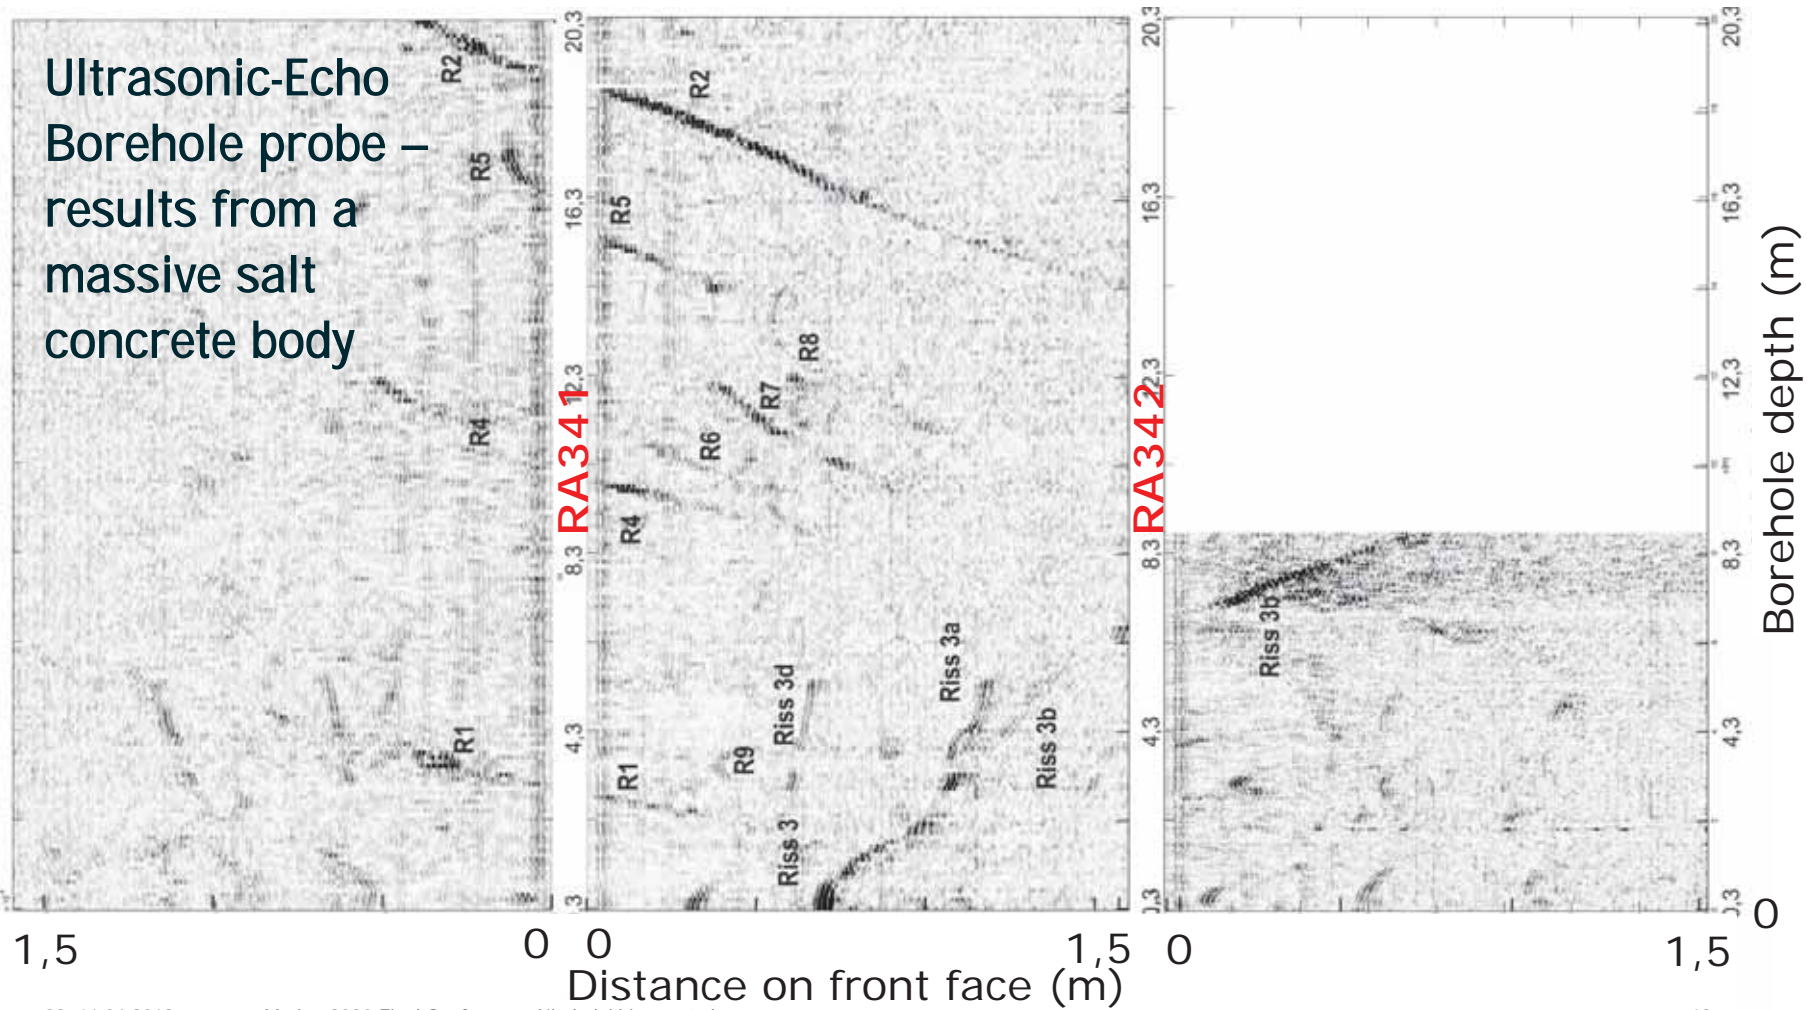
Ultrasonic-Echo
Borehole probe –
results from a
massive salt
concrete body

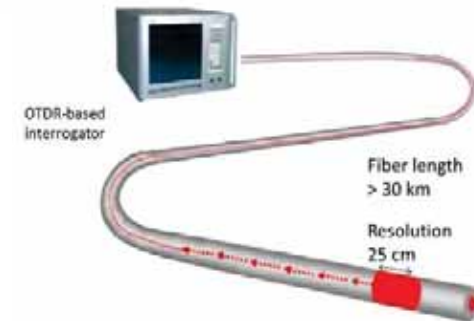
Figure 2.10 Distributed fiber optic sensor.
