Modern2020

Non-Intrusive Geo-Electrical ERT Monitoring of High-Level Radioactive Waste Experiments in Tournemire URL

10th March 2019, Paris-FR

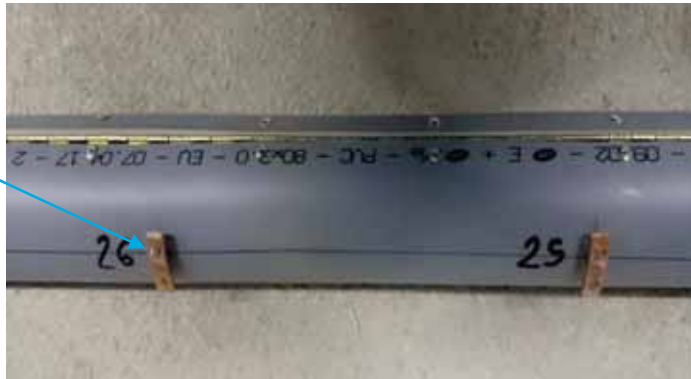
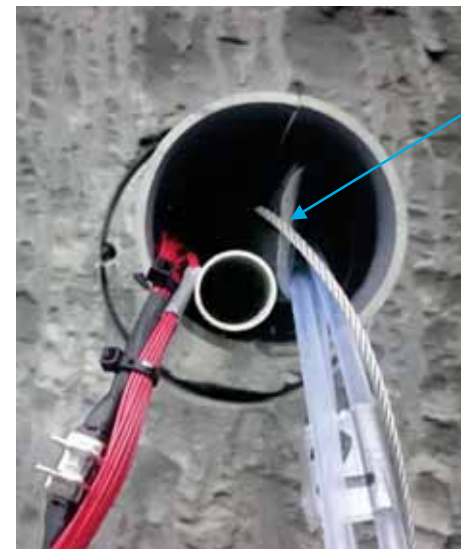
Borehole electrodes design

Copper
Electrode
(1.5x3cm)

Inflatable system

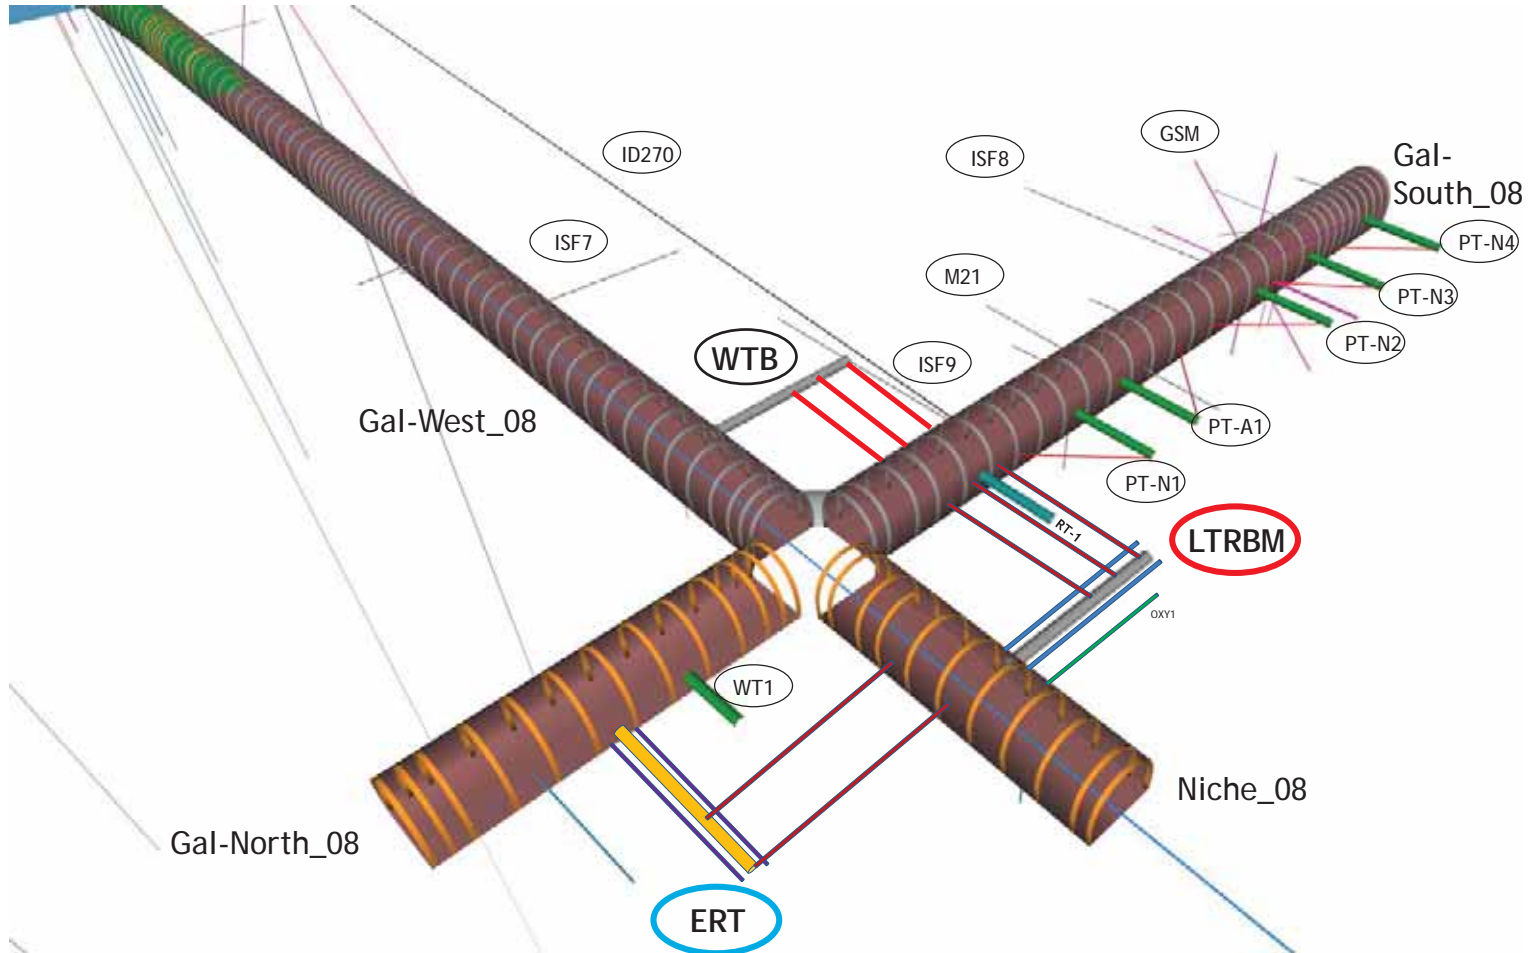
Location of experiments in Tournemire URL

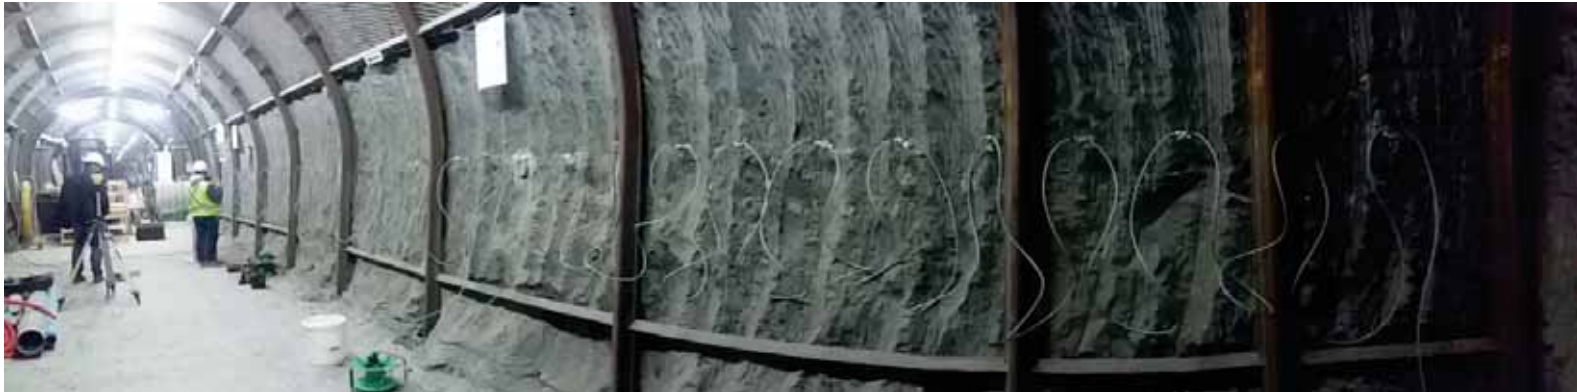
Jan 2017: Blank test #1

Electrodes spacing	0.4m
Total number of electrodes	48
Total length	18.8m
Position of electrodes in z-axis	1.4m from the gallery floor
First electrode (EI 0) in x-axis	On the right: standing on Gallery North_08 and facing the ERT demonstrator location
Measurement type	2D surface
Unit used	ARES II
Array used	Schlumberger
Electrodes used	Conventional metal sticks (surface)

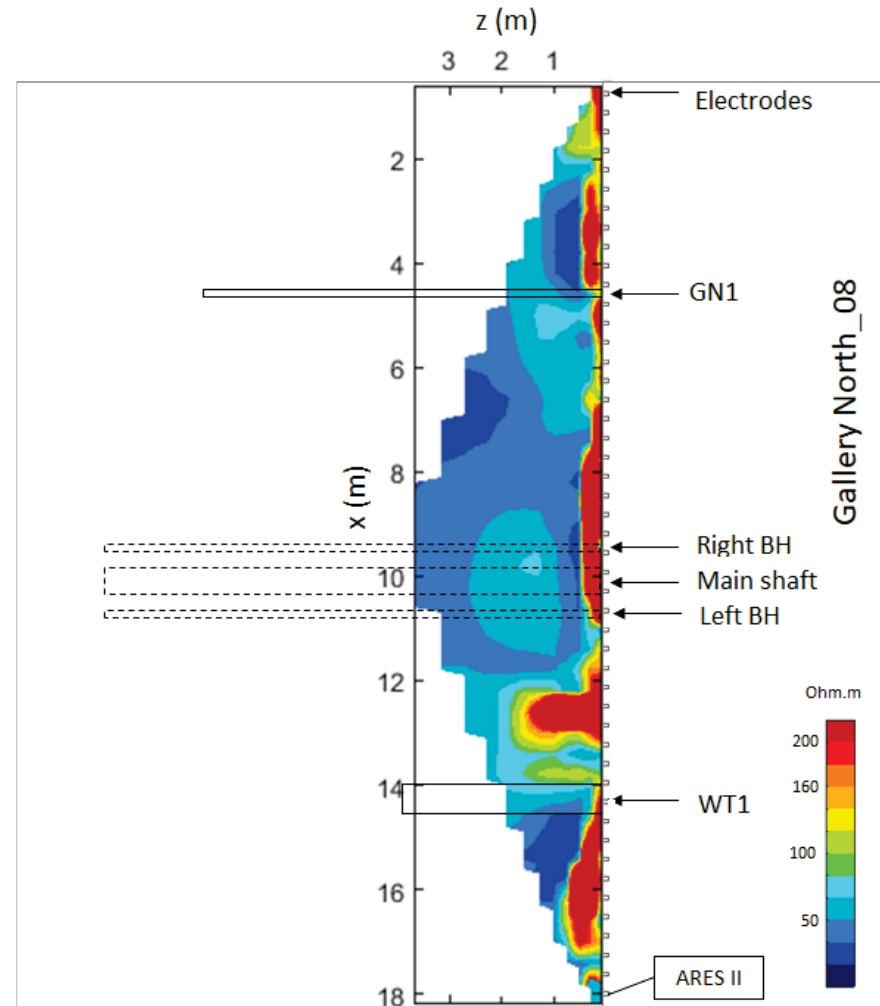
Jan 2017: Blank test #1

- Largest contact resistance = 3.5 k Ω
- Mean stacking error = 0.16%
- RMS = 9.2%

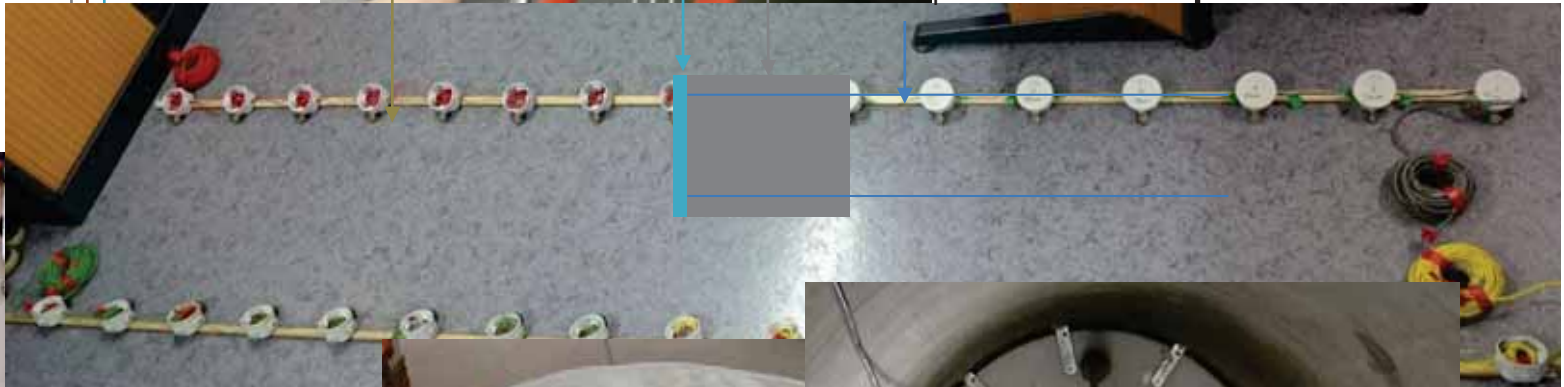
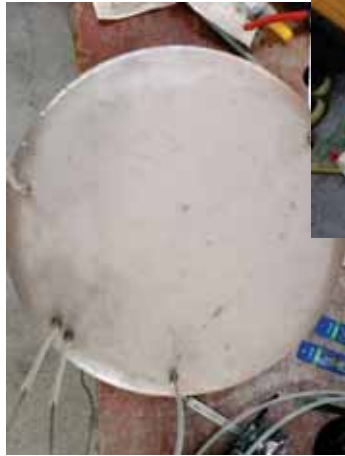
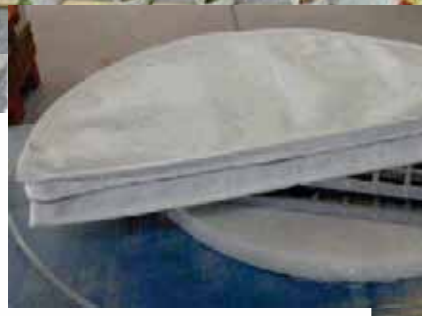
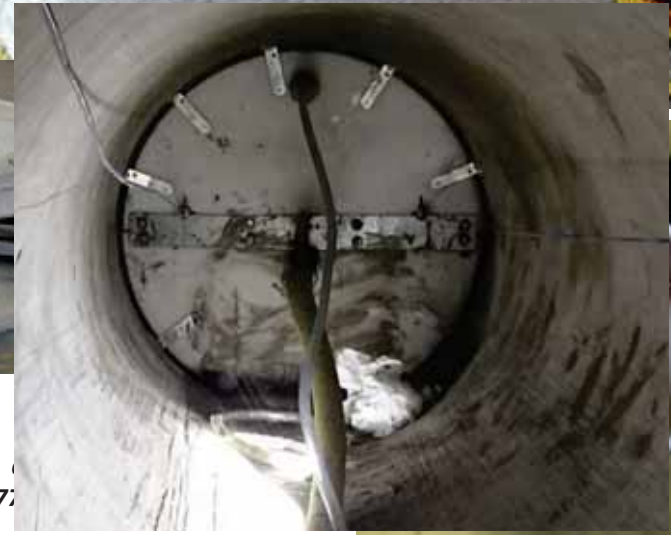
Jun - Sep 2018: Installation

Concrete layer

Heater

Hydration mat 1

Bentonite buffer

Hydration mat 2

Cement plug

Fibre optics

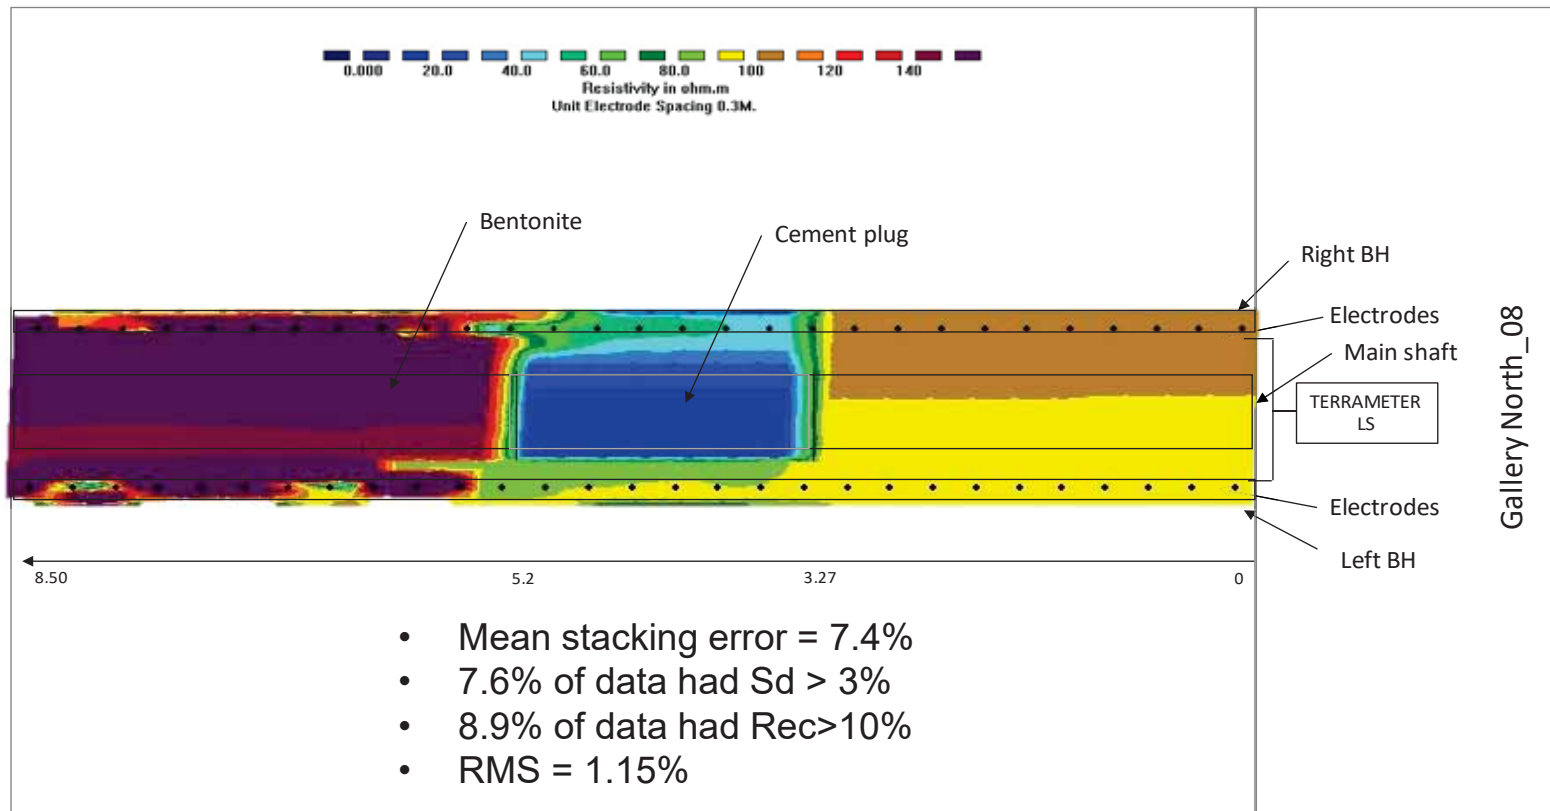
October 2018: Day 36

ERT surveys to monitor hydration and heating

- Host rock resistivity around both experiments area is quite homogenous and $< 100\Omega\text{m}$;
- Preliminary results of the monitoring period for both experiments are also promising, different materials within the installation are identifiable and changes in resistivity due to water injection are also expected to be noticeable.
- The methodology developed for the electrode installation in boreholes and based on the use of PVC half tubes pushed against the borehole wall by inflatable pipes has proved to be successful. However, electrode contact resistance remains a challenge that needs to be addressed.

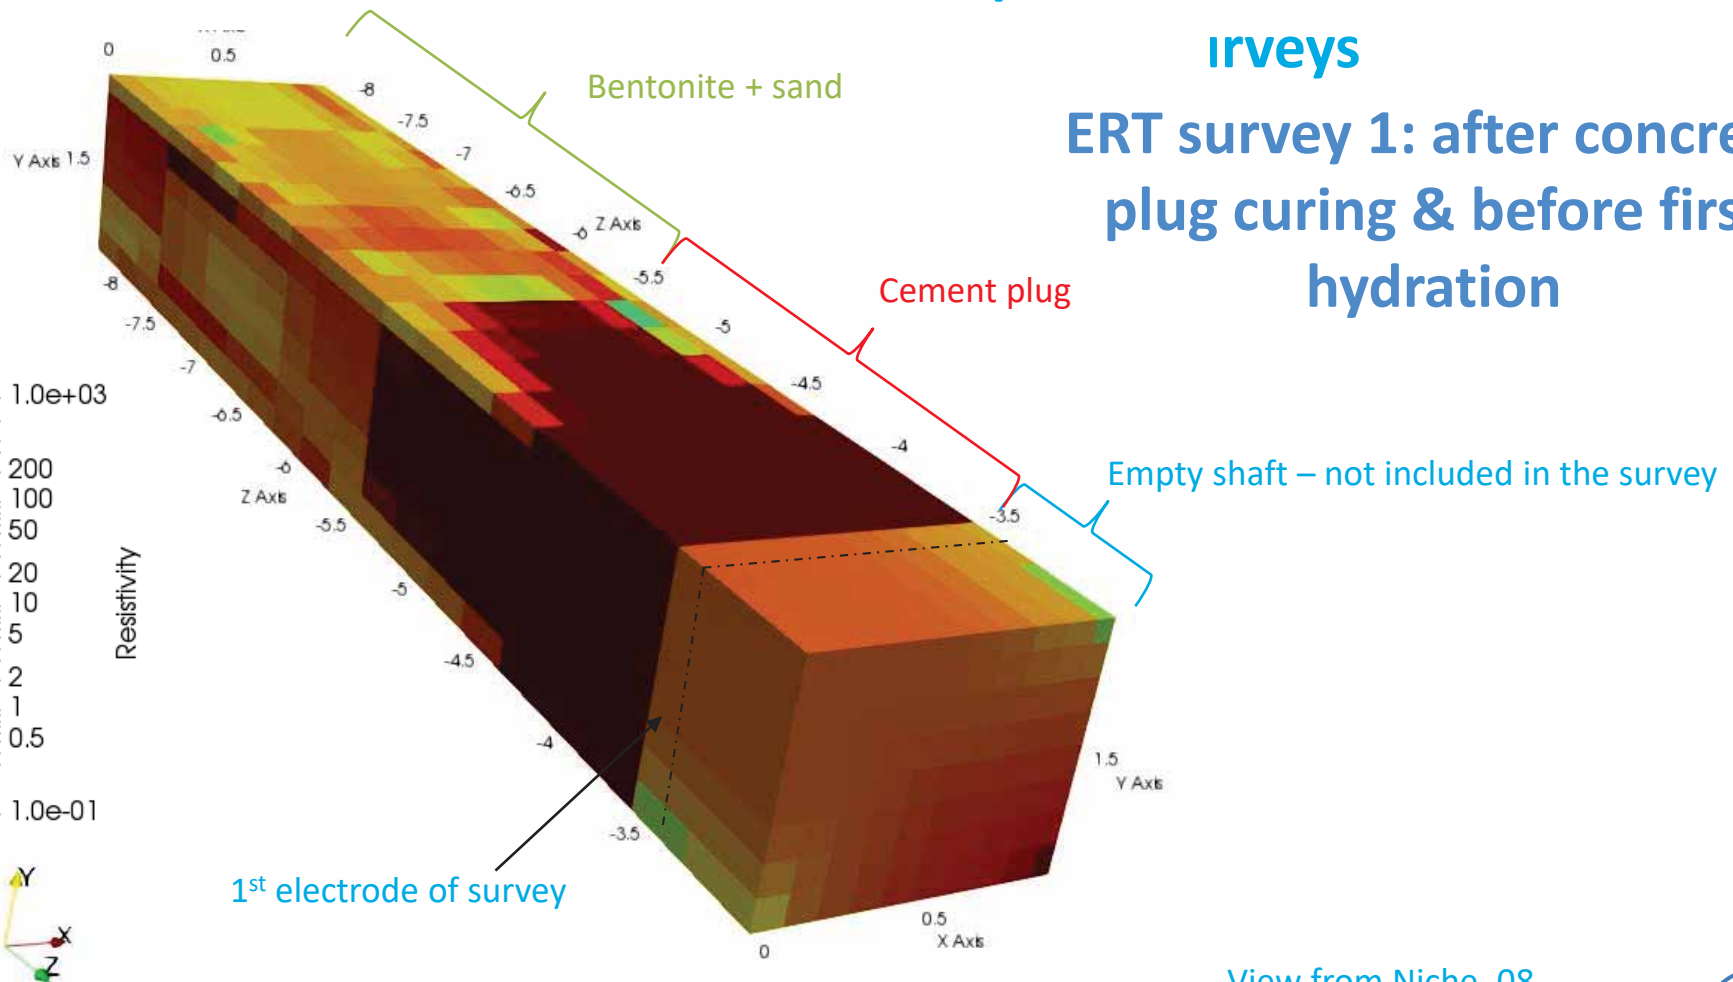
**ERT survey 1: after concrete
plug curing & before first
hydration**

View from Niche_08

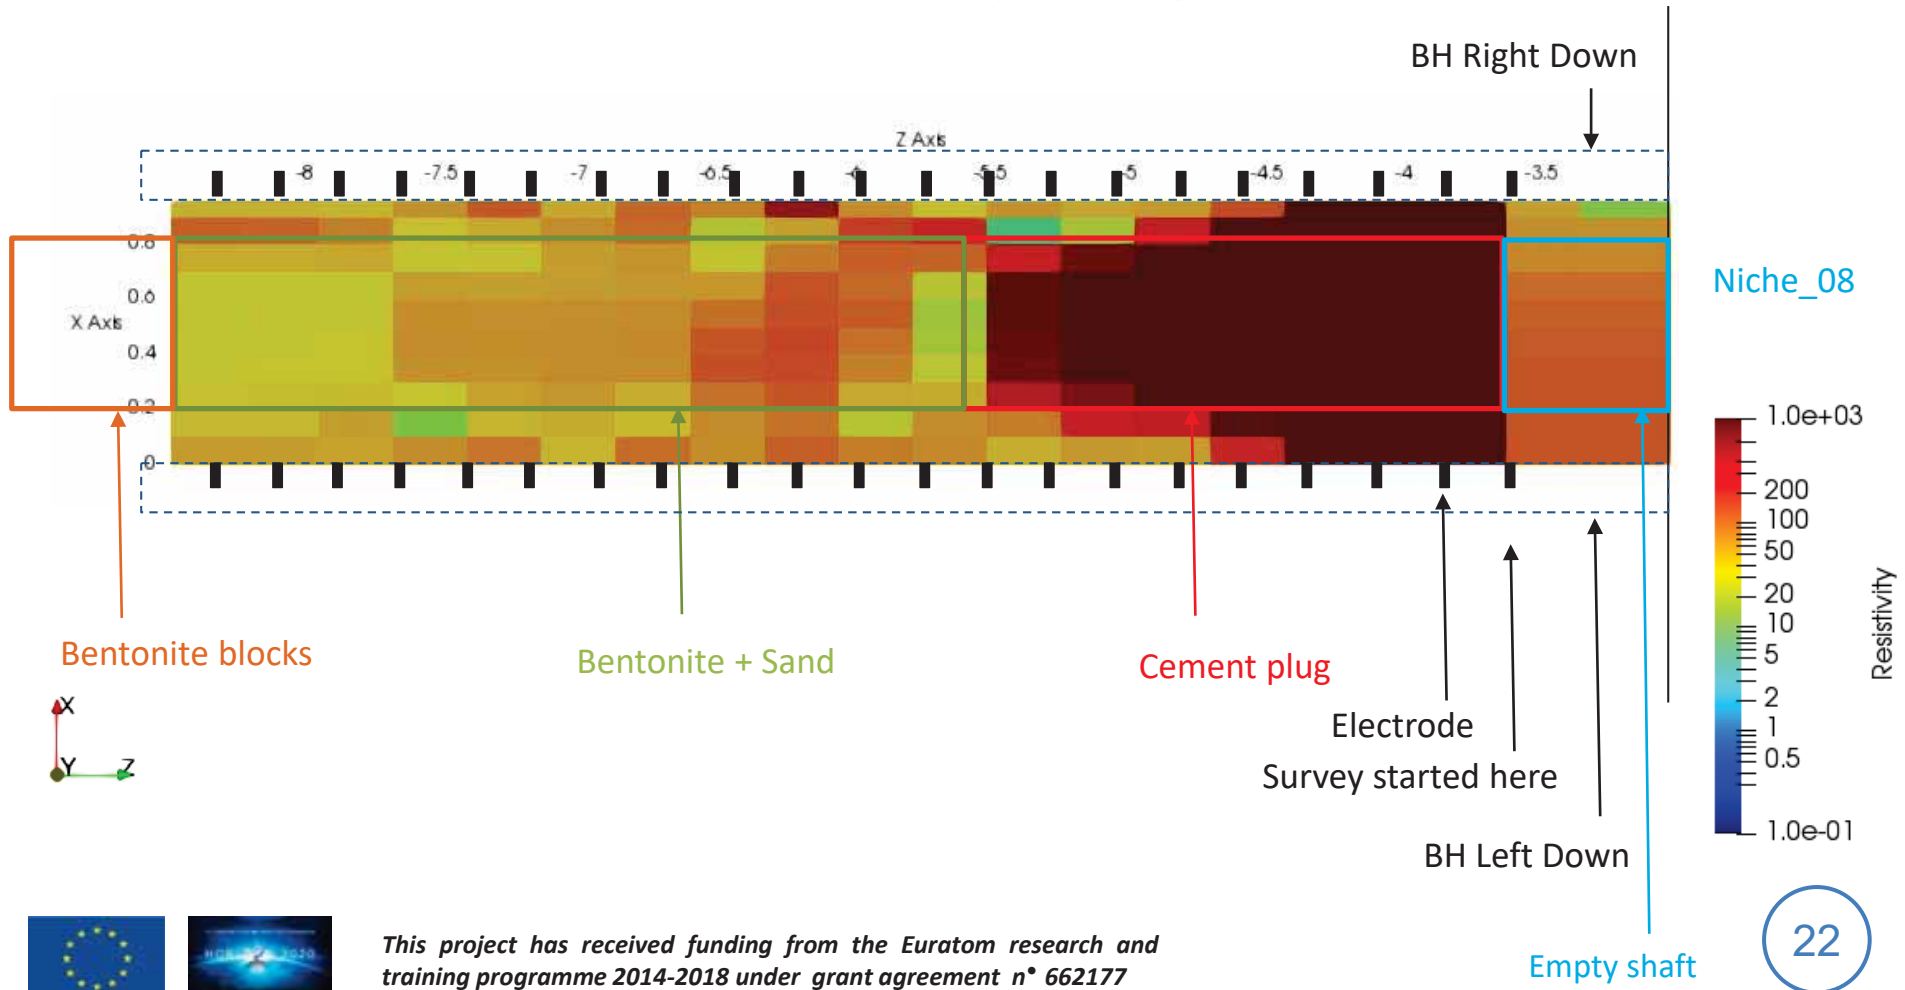
ERT survey 1: after concrete plug curing & before first hydration
