# Modern2020

# Monitoring the Full-scale Emplacement Experiment (FEBEX) over 18 years: lessons learned for future repository monitoring

### Florian Kober & Jose Luis García-Siñeriz

Paris, 10 Apr 2019

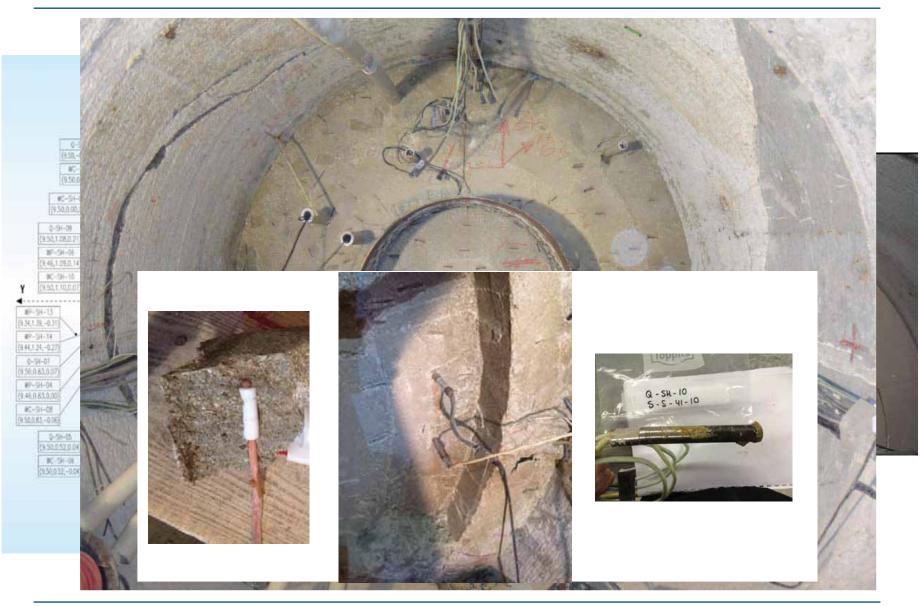
## 4.- Sensors during FEBEX-DP Dismantling Bentonite buffer (section 41)

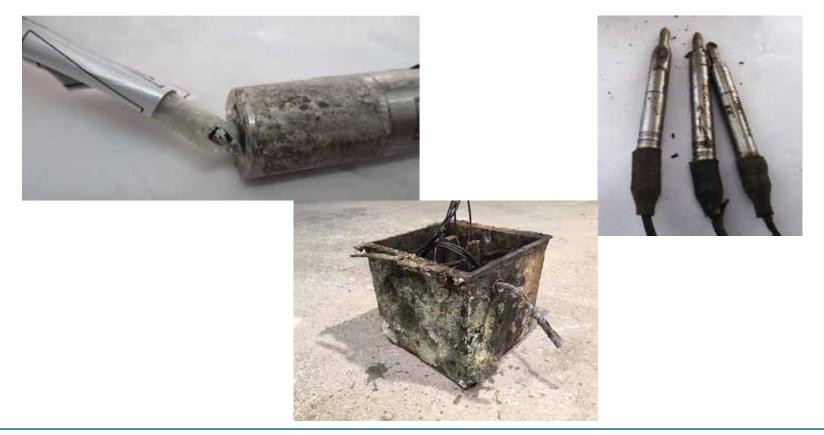
## Instrumentation – sensor type conclusions (1)

- Vibrating wire type: they showed to be robust and most of them remained operative problems with cable entries → loss of flexibility of plastics with time combined with the differential movements cable/metal body
- Prototypes of new sensors: they need of further improvement (mechanical protection and water isolation)
